IAEA QUALITY CONTROL ATLAS FOR
SCINTILLATION CAMERA SYSTEMS

Printed by the IAEA in Austria
April 2003
STI/PUB/1141

IAEA quality control atlas for scintillation camera systems / [compiled by E. Busemann Sokole]. — Vienna : International Atomic Energy Agency, 2003.

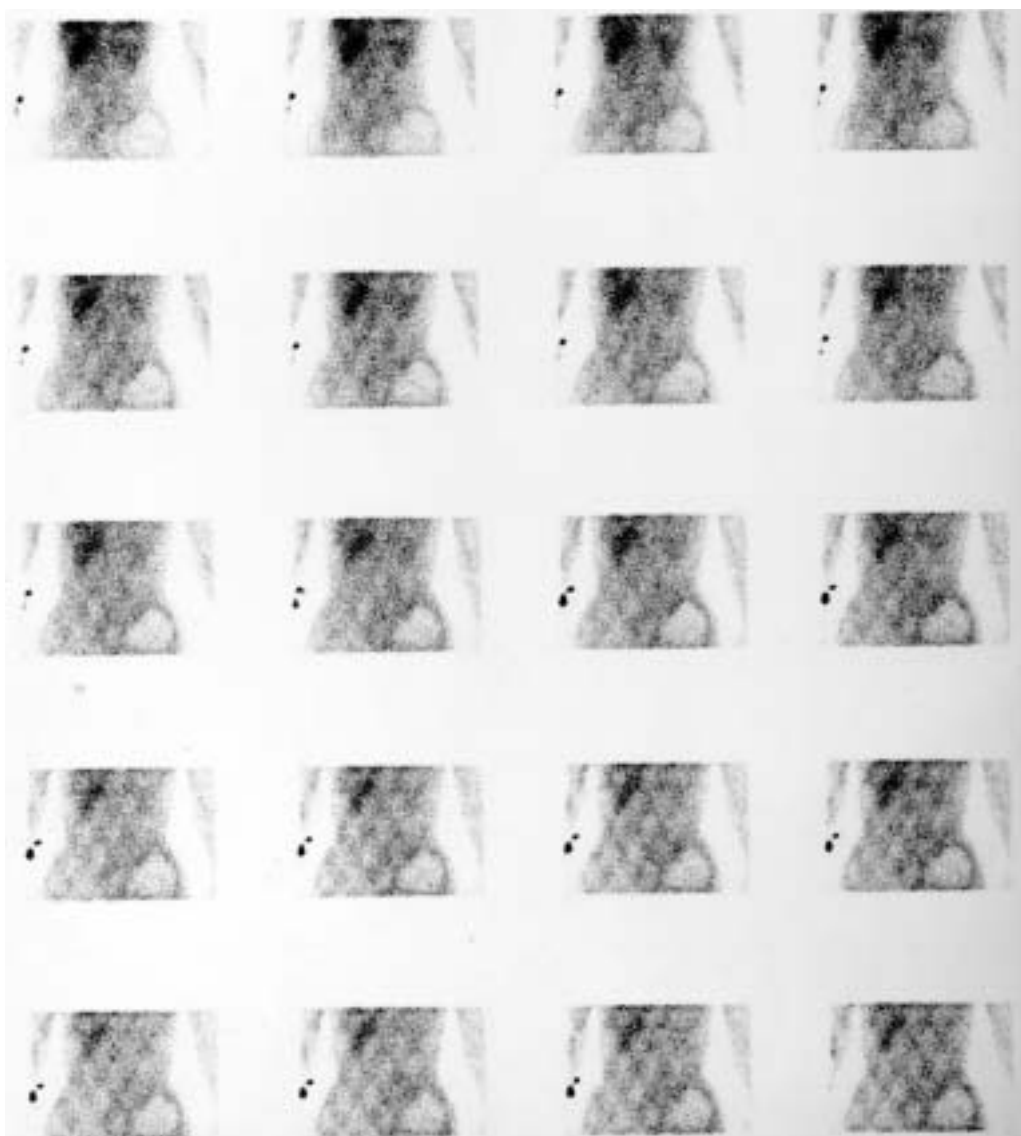
2.1.2B. Example: Clinical study — unstable energy window setting (2)

Clinical study of a patient who underwent a dynamic ^{99m}Tc DTPA study of the kidneys. The 20 consecutive images (30 s each) shown here were obtained in the posterior view starting at 1 min (top left) after intravenous injection of 110 MBq of ^{99m}Tc DTPA. The 20% energy window had been set over the photopeak of ^{99m}Tc before the study was started.

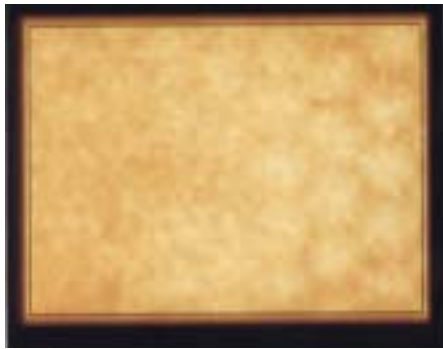
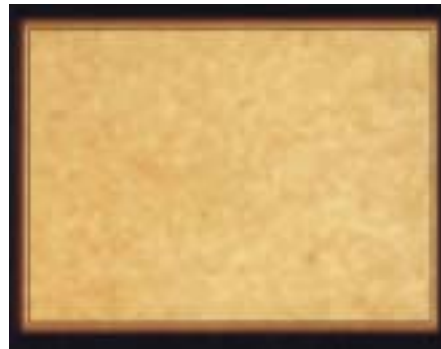
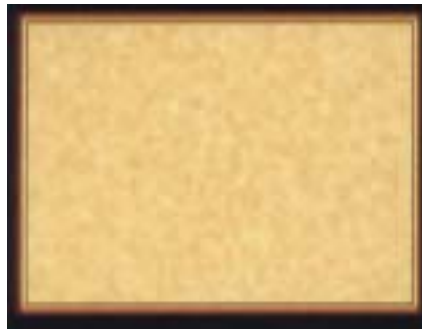
2.2.1B. Example: Symmetric 10%, 15% and 20% energy windows (1)

10% energy window

15% energy window

20% energy window

Intrinsic uniformity, ^{99m}Tc , 30 million counts each image, no contrast enhancement of images, acceptance testing.

Results: Comparison of the three images shows a degradation in uniformity as the window width is decreased. At a 10% energy window, a pattern of PM tubes is seen in the right half of the uniformity image. The scintillation camera was retuned.

Comments: This test assesses the state of tuning of the PM tubes. Uniformity can be slightly degraded as the energy window width is decreased. It is not unusual to obtain non-uniformity at a 10% energy window, but the asymmetry in non-uniformity observed in this example indicates a problem. Periodic performance of this test is important to assess the state of tuning of PM tubes and when narrow energy windows are clinically used (e.g. when performing dual isotope studies).

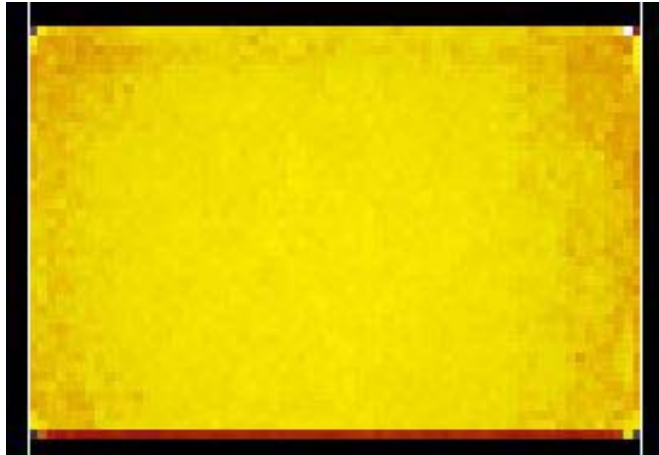
2.2.1E. Example: Symmetric energy window — source too close to detector in intrinsic uniformity measurement

Intrinsic uniformity image, ^{99m}Tc point source, detector to source distance of about 3 FOV, 30 million counts, 20% symmetric energy window.

Results: The image shows increased counts towards the centre (more uniformly intense yellow in this colour table) and a fall-off in counts towards the edge of the FOV. This convex response (dome effect) is the result of the point source being too close to the detector. Apart from this dome effect, the general appearance of the image shows no obvious uniformity defects. However, for a proper assessment of more subtle non-uniformities, a software inverse square correction should be applied. Alternatively, if the detector configuration permits, the source should be placed at more than 5 FOV distance from the detector.

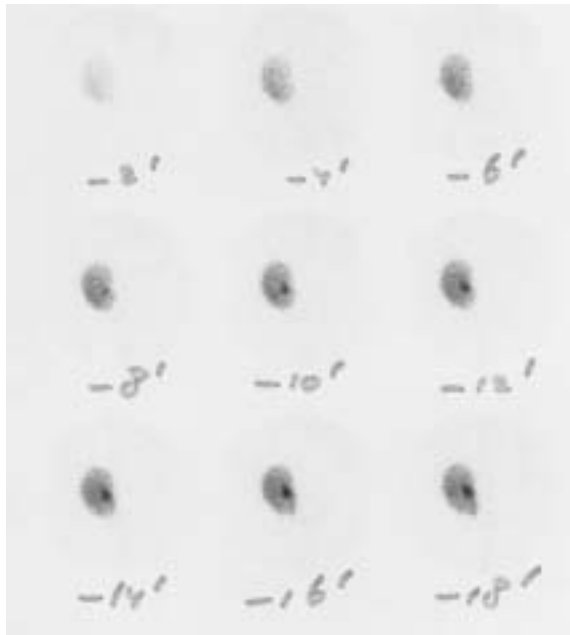
2.2.2M. Example: Asymmetric energy window — clinical example with ^{123}I and $^{99\text{m}}\text{Tc}$

A: first series

In this study, using this camera, the hot artefacts were caused by the asymmetry of the ^{123}I energy window over the ^{99m}Tc photopeak in the presence of ^{99m}Tc .

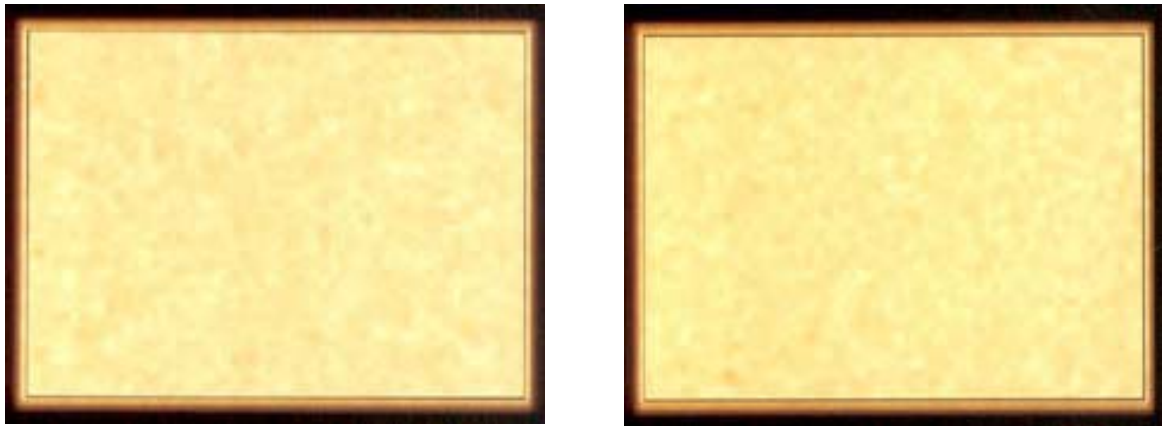
2.2.3.1C. Example: Comparison of intrinsic uniformity for ^{201}Tl and ^{67}Ga on the same scintillation camera — radionuclide specific uniformity correction map

Intrinsic uniformity, 30 million counts each image, radionuclide specific uniformity correction, 20% energy windows.

L: ^{201}Tl with a 20% energy window at 72 keV.

Results: Slightly degraded uniformity compared with the uniformity of $^{99\text{m}}\text{Tc}$ (not given here). Acceptable.

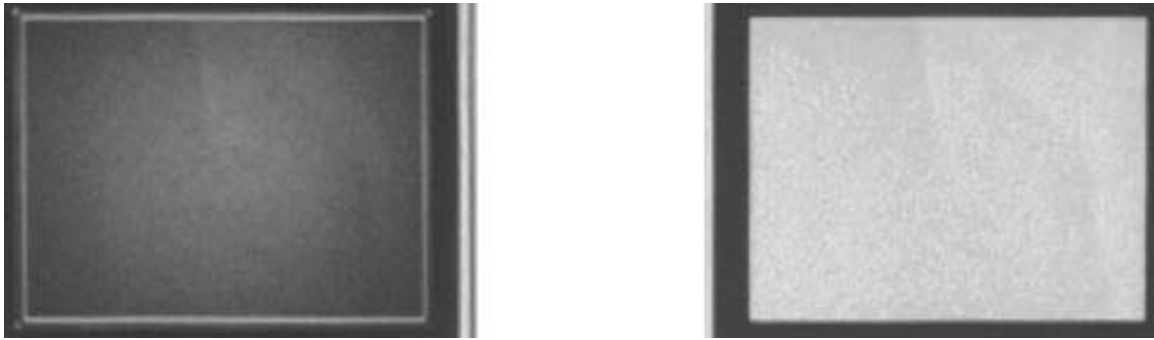
2.2.7.1B. Example: Loss of optical coupling

2.5 million count intrinsic flood image acquired with ^{99m}Tc on a triple head SPECT system. The point source was centred between the detector heads, which were retracted maximally. Detector to source distance was only about 1 UFOV.

L: Raw data.

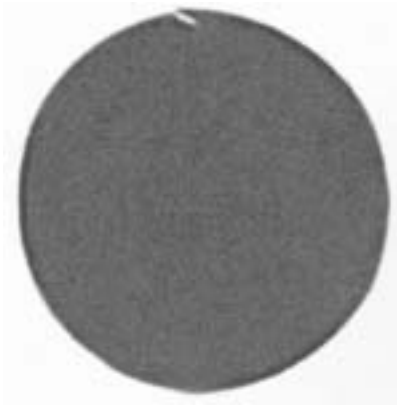
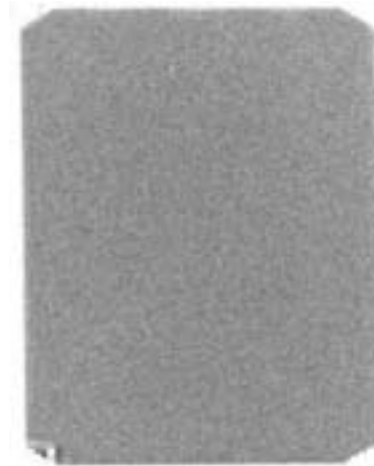
2.2.7.2C. Example: Cracked crystal — puncture/impact (3)

Two different examples of a routine intrinsic flood field uniformity image showing a small crystal crack at the edge of the detector.

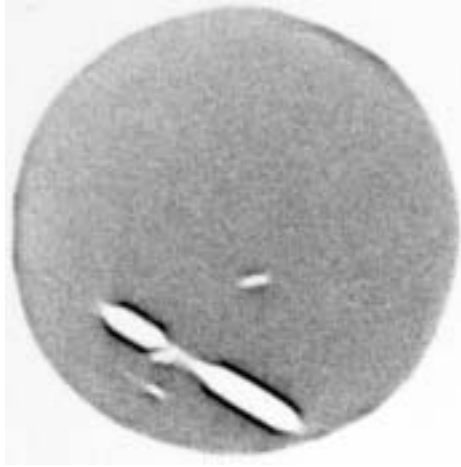
A

Routine intrinsic uniformity image shows various cold areas with hot edges. These are due to a thermal crack.

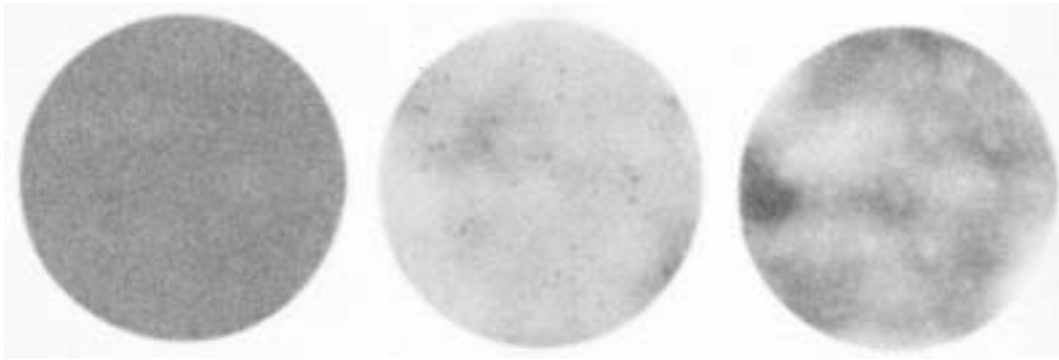
2.2.7.4F. Example: Crystal hydration (6)

Intrinsic flood images, ^{99m}Tc point source, 20% energy window, 3 million counts each image.

- L: Symmetric energy window.
- M: Asymmetric energy window set low.
- R: Asymmetric energy window set high.

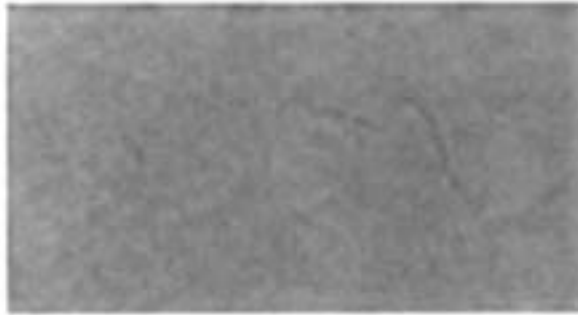
2.2.7.5. Example: Crystal manufacture — irregularities within the crystal

Acceptance testing, intrinsic uniformity, 15% symmetric energy window, 30 million counts.

T: Smoothed uniformity image.

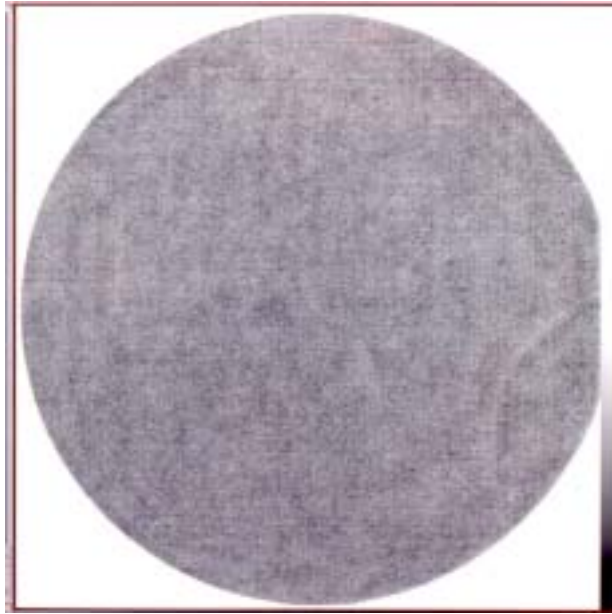
B

Acceptance testing, intrinsic uniformity, 15% symmetric energy window, 30 million counts, 512×512 matrix, some contrast enhancement.

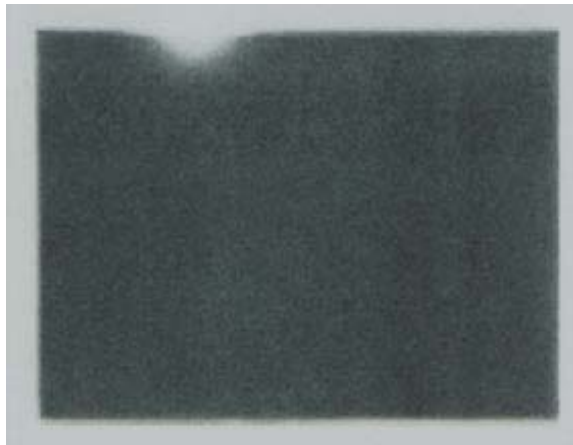
2.2.8.4. Example: Uniformity — defective PM tube at edge of FOV

^{99m}Tc , 15% symmetric energy window, 256×256 matrix, 10 million counts.

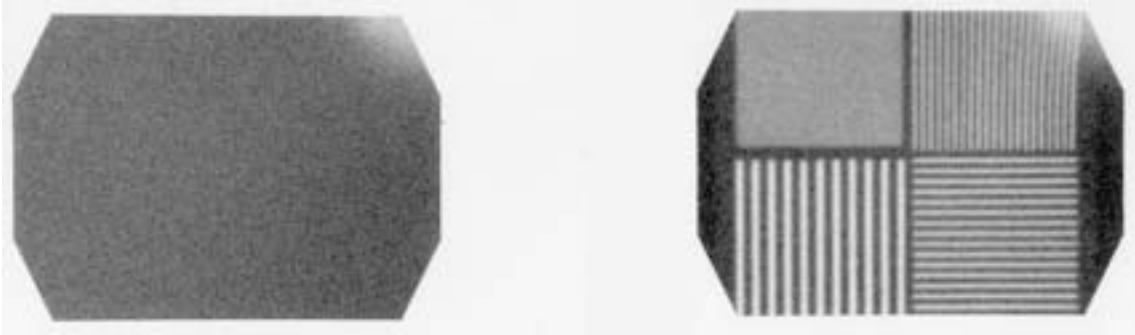
2.2.8.10. Example: Faulty PM tube preamplifier

Routine intrinsic uniformity check with ^{99m}Tc , 15% symmetric energy window.

L: Uniformity image.

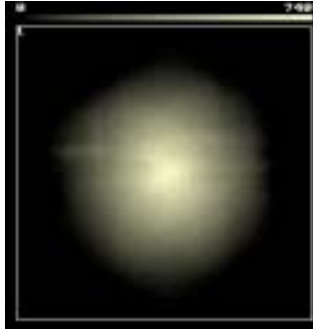
Digital acquisition made in a 256×256 matrix. The horizontal stripes show that there is hole misalignment for several rows of holes in this collimator. The collimator requires replacement.

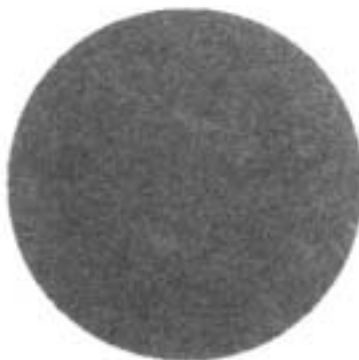
B

Routine system uniformity, ^{99m}Tc flood source, 20% energy window, 3 million counts.

A: LEHR (left) and high energy (right) collimators on the same scintillation camera.

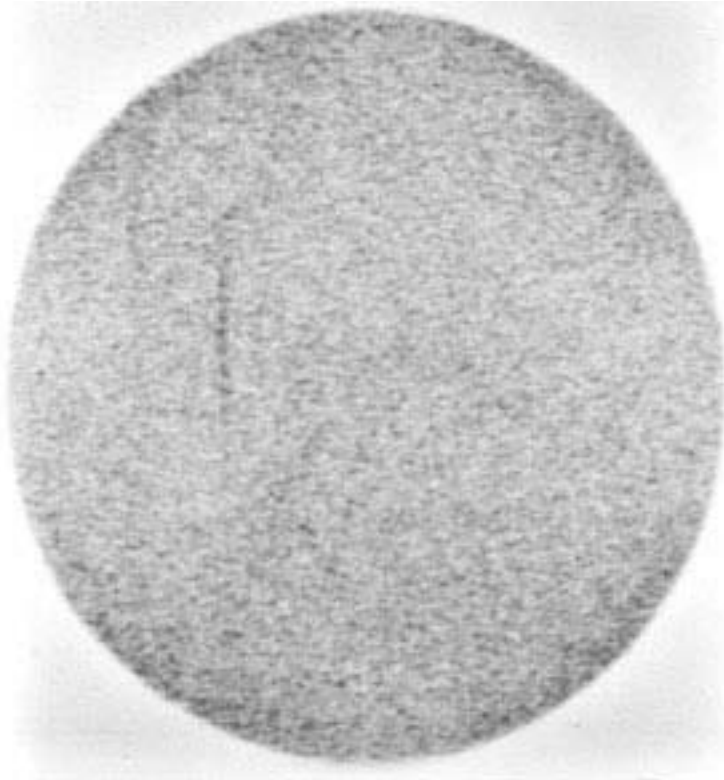
^{99m}Tc , 15% energy window, 30 million counts, LEHR collimator.

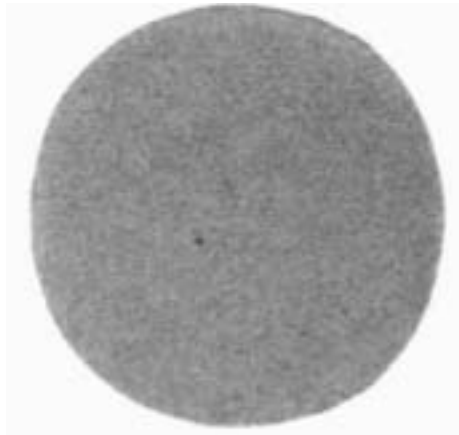
2.2.10.2D. Example: Cobalt sheet source — non-uniformity in source (2)

⁵⁷Co flood image, 20% energy window, low energy collimator, 10 million counts.

Results: A tiny hot spot to the left of centre in the image was produced by non-uniformity in the ⁵⁷Co flood image.

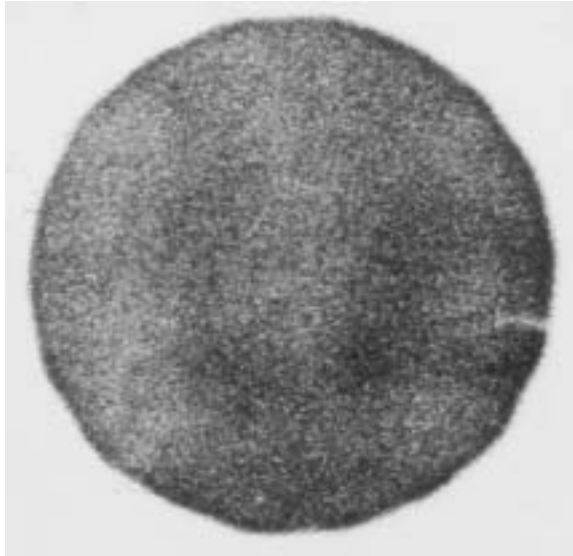
Extrinsic uniformity, ^{57}Co sheet source, 20% energy window, 3 million counts.

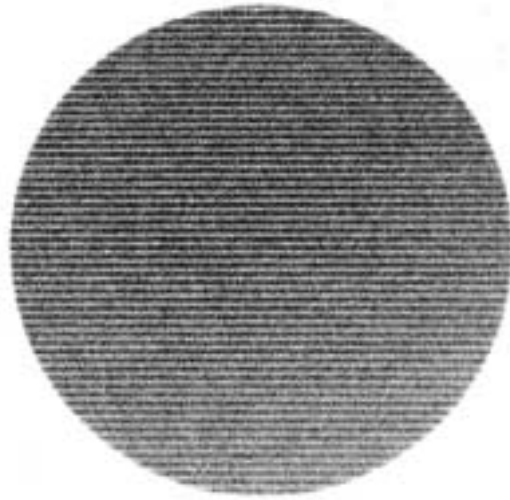
PLES phantom: The PLES phantom requires only two images to evaluate the spatial resolution and linearity. However, PLES phantoms with bars of different sizes and spacing are needed for cameras with different spatial resolution. The example below is an image of the PLES phantom for assessing the spatial resolution and spatial linearity in one direction. This image was made after reacquiring a linearity correction map.

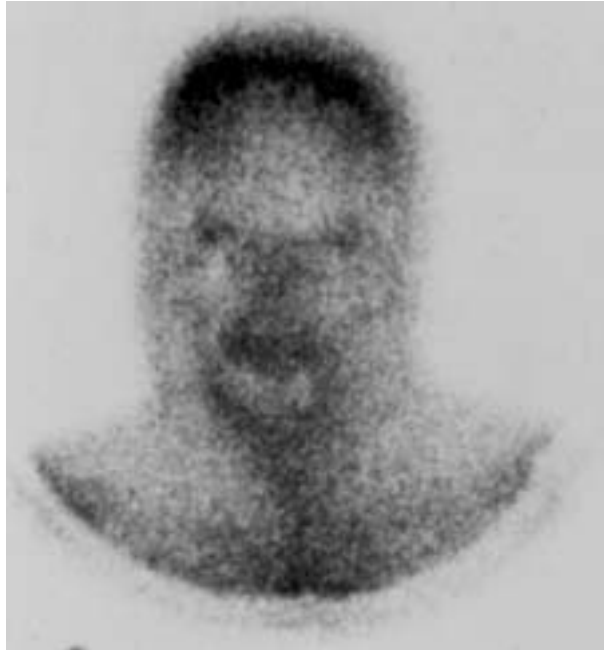
2.4.6. Example: ^{67}Ga MWSR error — clinical

^{67}Ga citrate image of the head, medium energy collimator, summed image of three images obtained with the preset energy windows of 93, 183 and 296 keV.

Results: Image shows poor spatial resolution due to poor MWSR. The scintillation camera requires service.

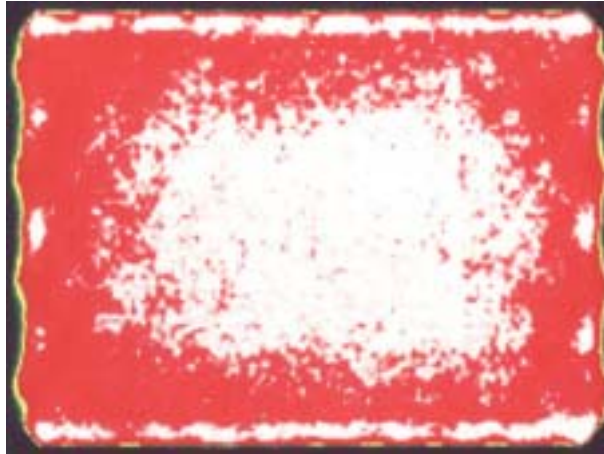
2.5.4. Example: Uniformity — poor image — misplaced events

Intrinsic uniformity at high count rate, $^{99\text{m}}\text{Tc}$, 20% energy window, 10 million counts in 97 s (103 000 counts/s), 128×128 matrix.

Results: There is an accumulation of counts towards the centre of the FOV, indicating misplaced events.

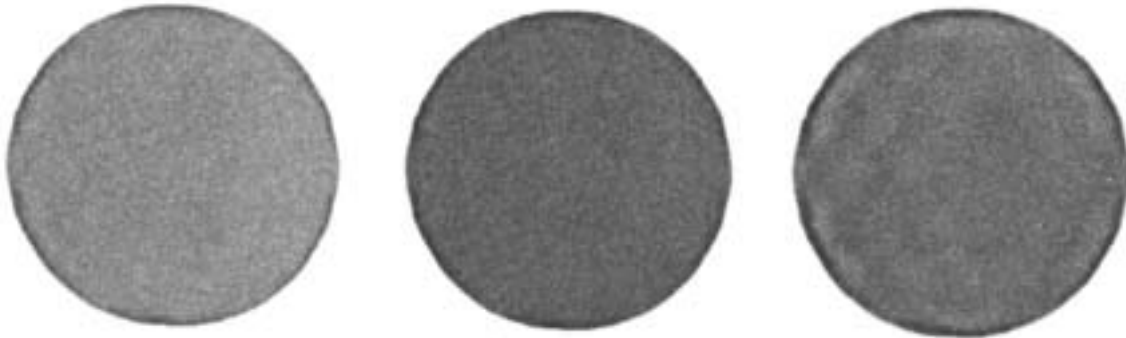
2.5.5. Example: High count rate — auto-high operating mode

Analogue scintillation camera, intrinsic uniformity at low (<20 000 counts/s) and high (~75 000 counts/s) count rates, ^{99m}Tc , 20% energy window.

- L: Low count rate, camera operated in normal mode.
- M: High count rate, camera operated in normal mode (as normally used at low count rates).
- R: High count rate, camera operated in auto-high mode (designed for high count rate imaging, whereby the event integration and unblank time are shortened).

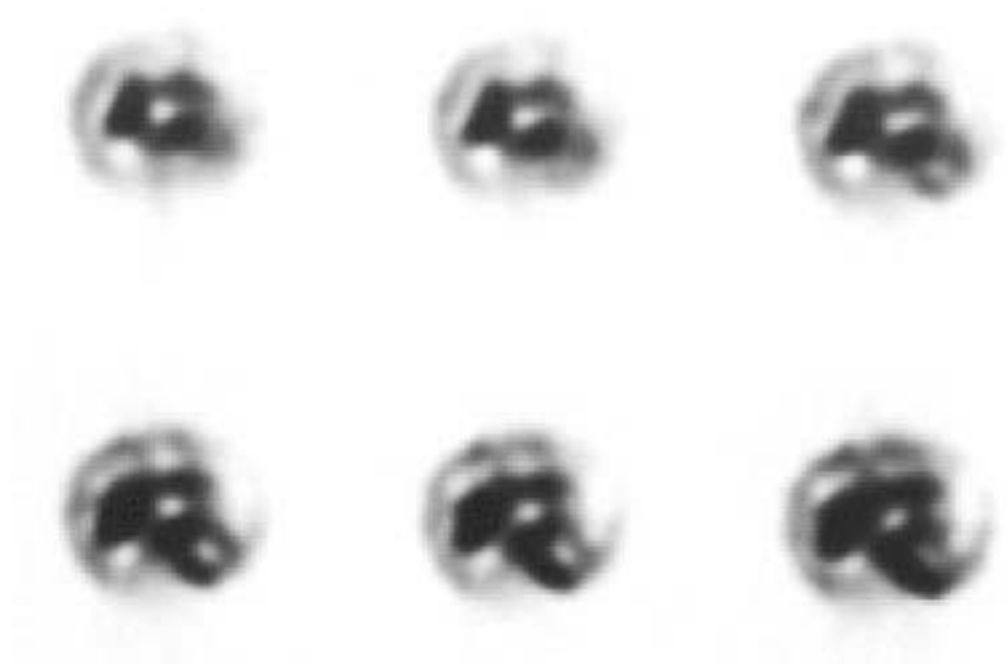
3.3.8. Example: Clinical study with large COR offset error

Clinical SPECT transaxial images of the liver using ^{99m}Tc sulphur colloid. The camera had just been installed and the COR calibration had not been done correctly.

Results: Because the COR calibration was done incorrectly, there was a very large COR error. The images were so distorted that the organ could not be recognized.

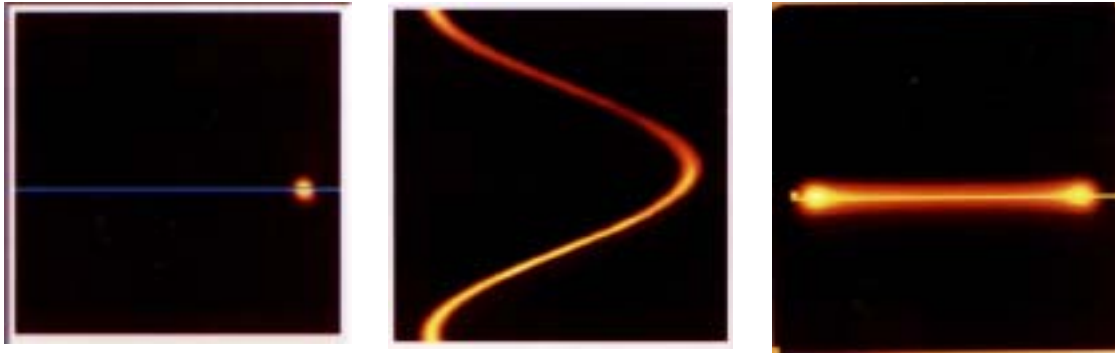
3.5.1. Example: Head tilt — offset point source — good result

One projection image

Sinogram

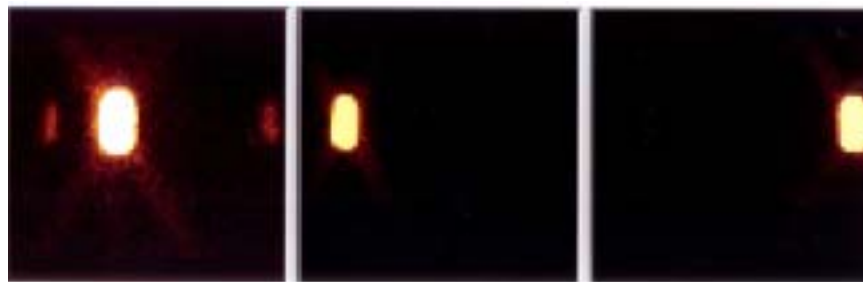
60 projection images

detector 1 at 0°

detector 2 at 120°

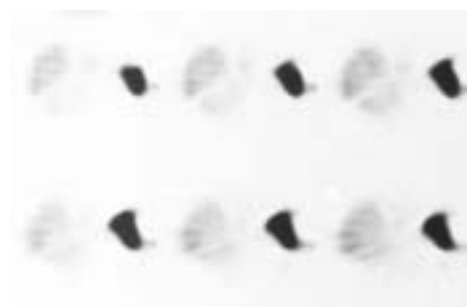
Unzoomed

B: SPECT transaxial slices

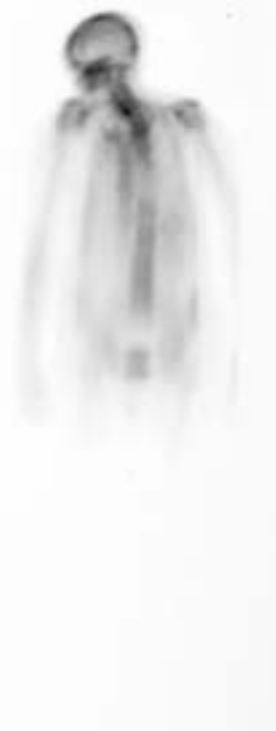
Routine whole body bone scan. Motion of the scan was from head to feet. The whole body scan started correctly as the electronic shutter opened, but during the subsequent motion the scan speed changed.

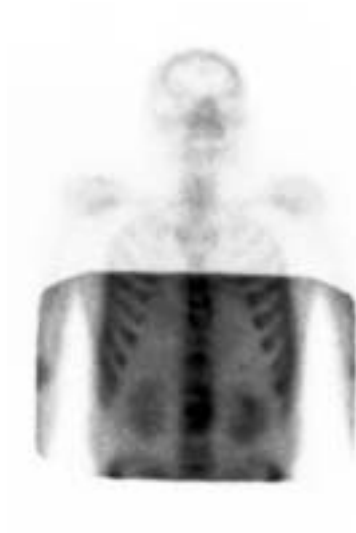
4.1.4. Example: Clinical whole body bone scan — motion stopped midway

Routine whole body bone scan. Motion of the scan was from head to feet. The scintillation camera was stationary, the bed was moving. During motion the bed stopped, but data acquisition continued.

Results: The image shows a large change in image intensity, and therefore in count density, between the moving and the stationary parts of the scan. The image size, however, remains the same. This was an intermittent problem that required service.

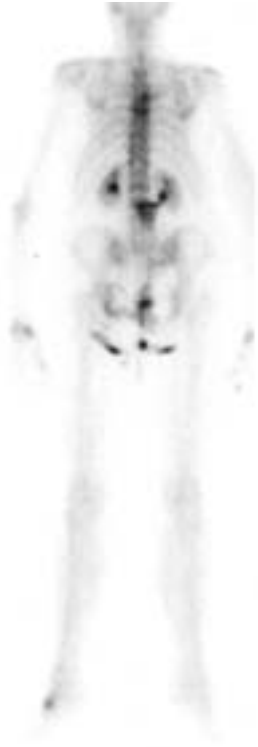
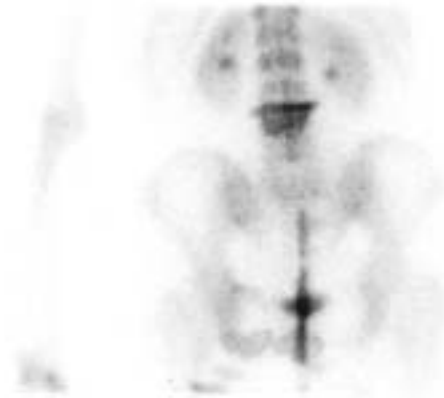
4.6.1B. Example: Whole body bone scan — radioactive contamination on clothing

Whole body scan

Static image

Whole body scan and static images of the skeleton in posterior view. The vertical and horizontal hot areas in the static scan do not correspond with skeletal features. They were due to radioactive urine contamination on the patient's clothing.

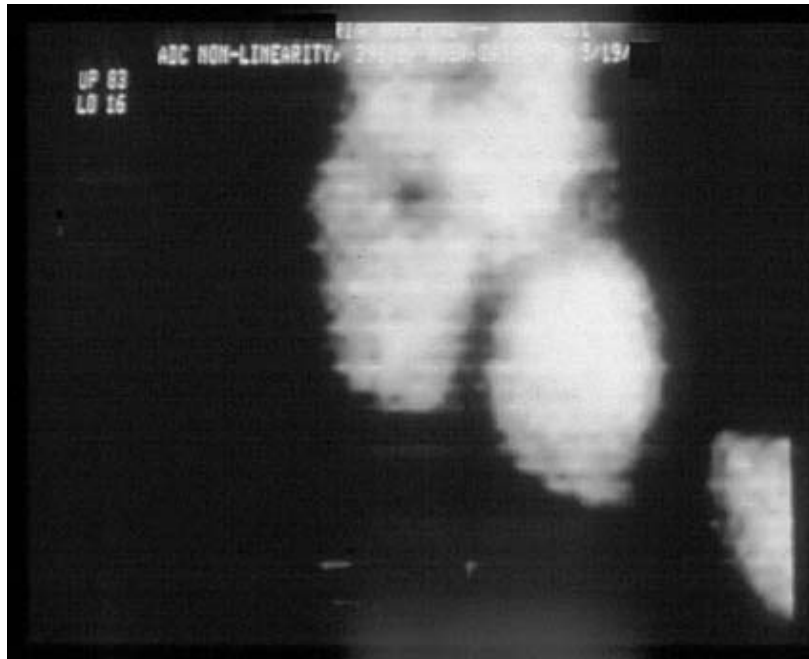
5.1.5. Example: Stripes in planar gated blood pool image

One image from a clinical planar gated blood pool study showing horizontal stripes due to non-linearity problems in the ADC of the computer interface.
